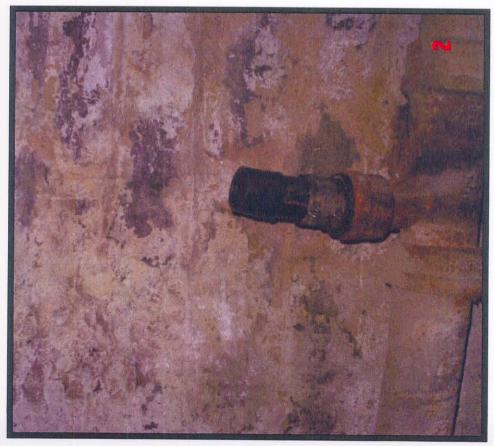
FS 13 – Evidence of pests. Mouse dropping observed

FS 13 – Open drain pipe allows for pest infiltration

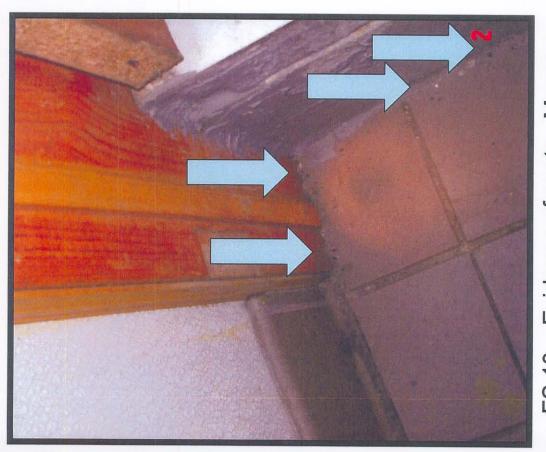
FS 13 – Evidence of pests. Mouse dropping observed

FS 13 – Large openings allows for pest infiltration

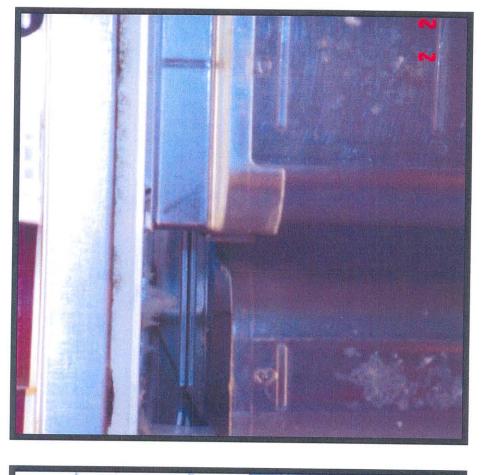
FS 13 – Large openings allows for pest infiltration

protected.
Cover for dairy dispensing container is missing. Mold is growing directly above open milk dispensing container.

FS 4 & FS 15 – Equipment is not properly cleaned and food is not protected.
